Water Compliance Inspection Report

**NPDES
Inspection Report**

**JLS Dairy
(NPDES Permit #: Unpermitted)**

Inspection Date: April 26, 2017

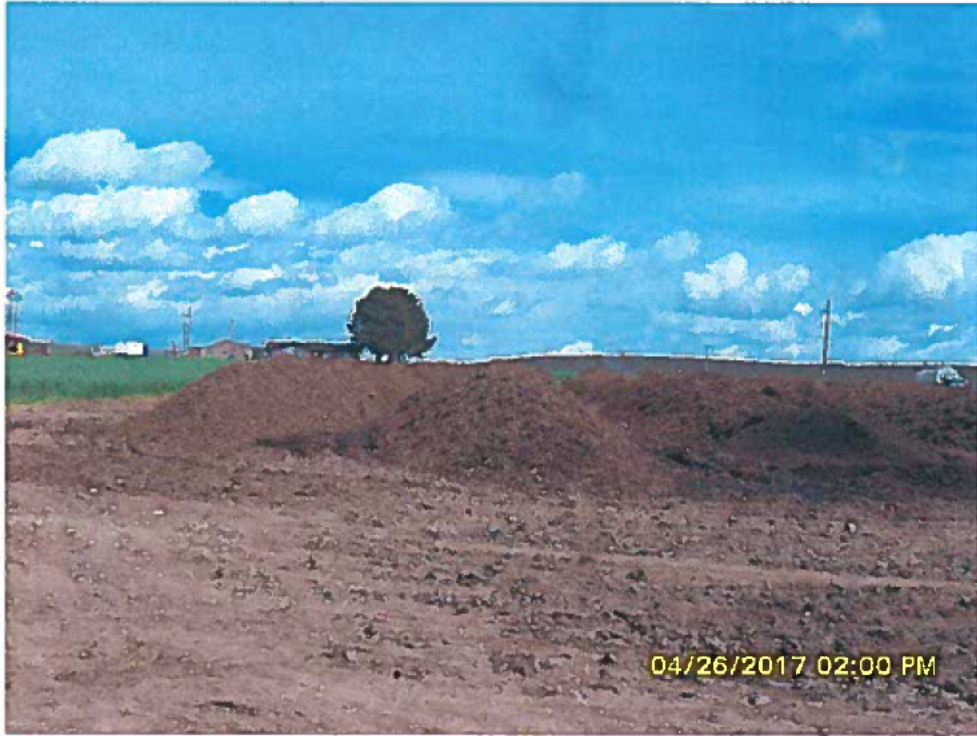
Photo #1: Easterly view showing compost piles. These piles are located near the southeast corner of the facility along Sheller Road. Camera photograph #SAM 2758.

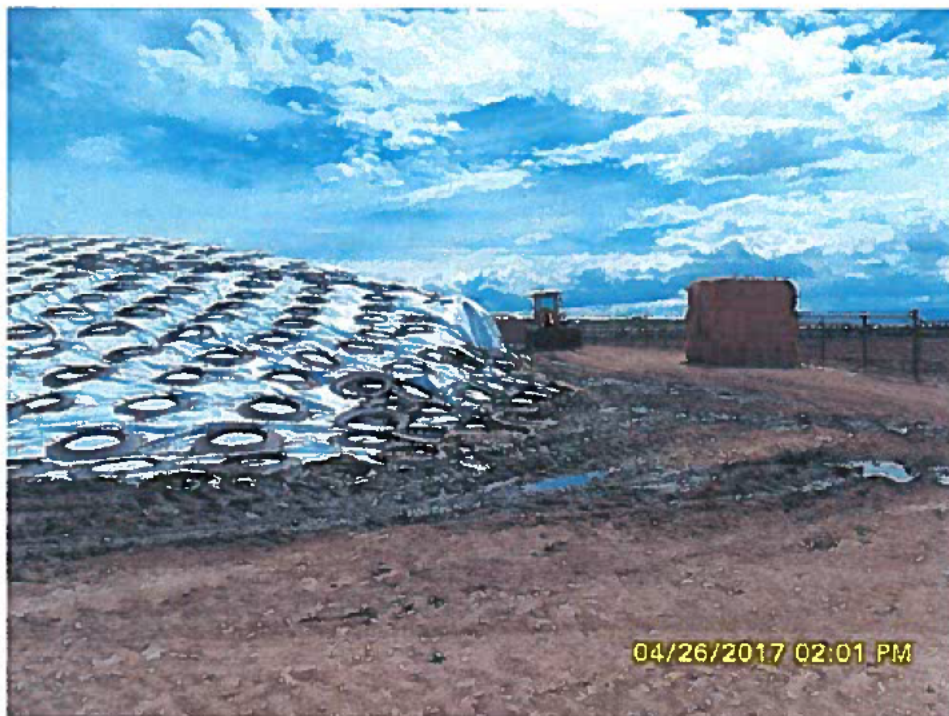
Photo #2: Southerly view showing the back end of a covered silage bunker. Camera photograph #SAM 2759.

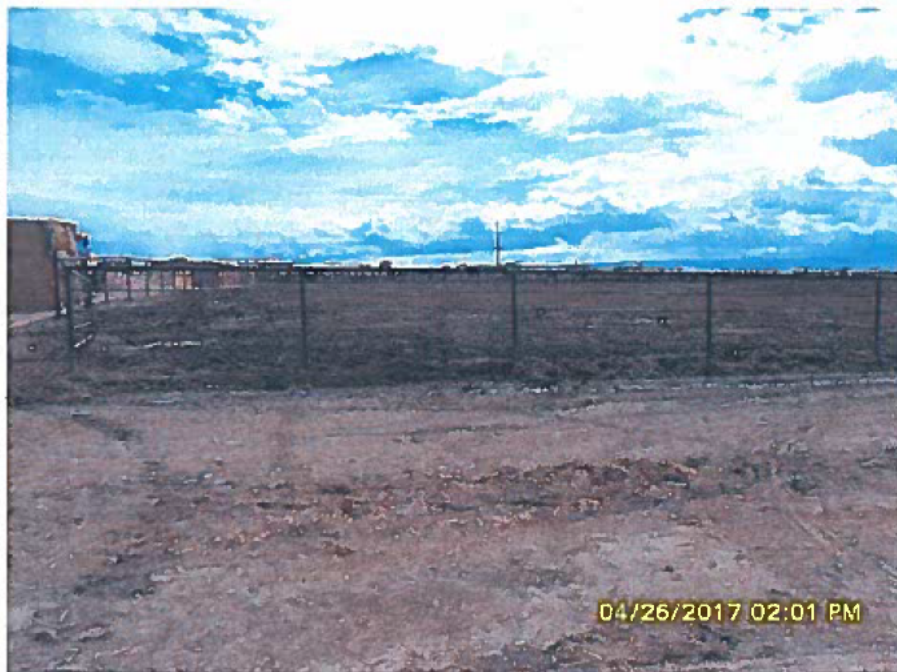
Photo #3: Southerly view showing a portion of the cow confinement areas. Camera photograph #SAM 2760.

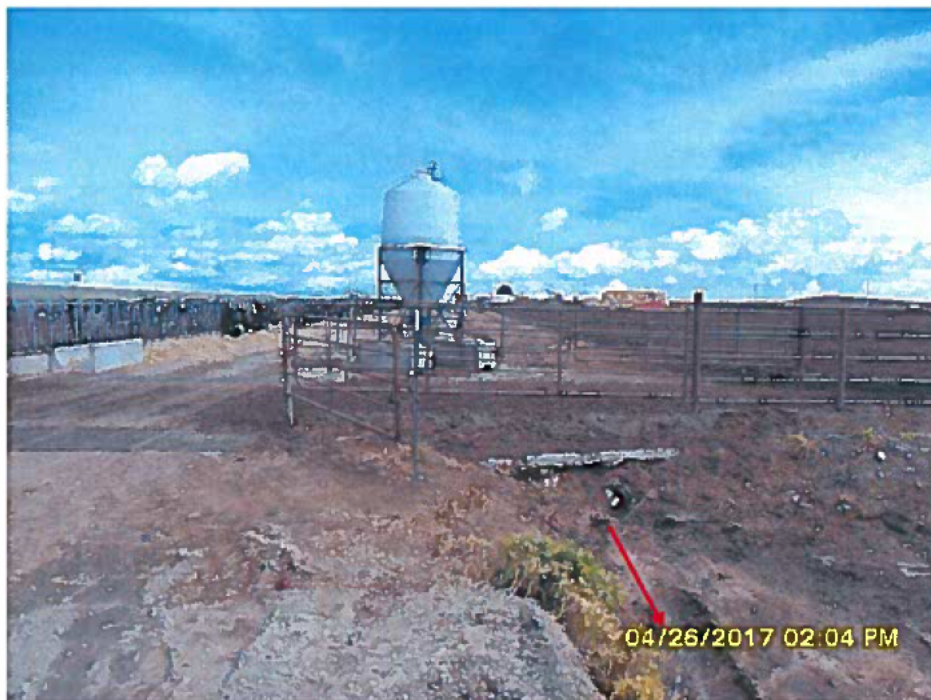
Photo #4: Easterly view showing the drainage pathway along the north side of the southernmost milking cow pens. Drainage from the southernmost pens enter this drainage pathway. This drainage pathway routes water to the west side of the facility. Camera photograph #SAM 2761.

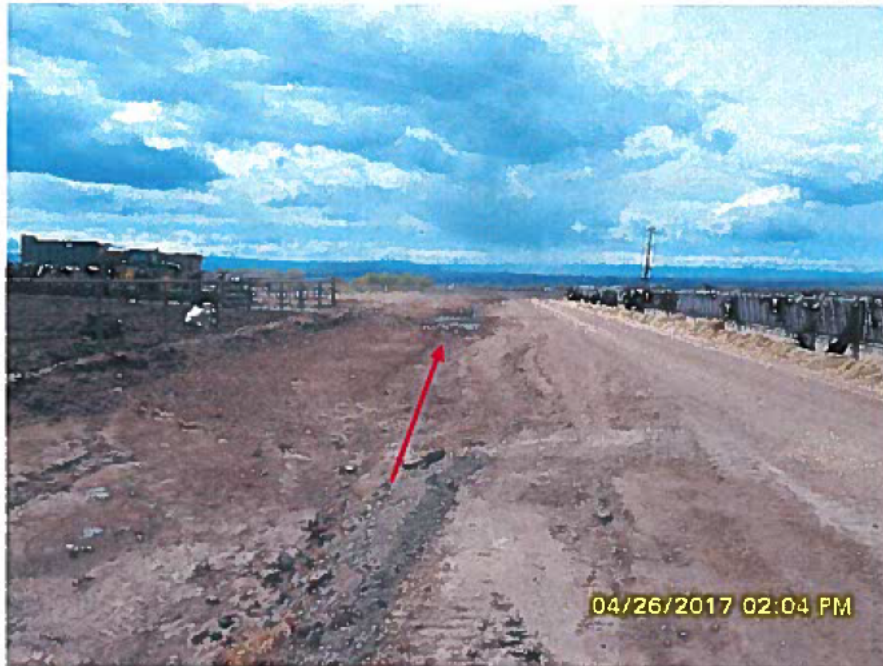
Photo #5: Westerly view showing the drainage pathway along the north side of the southernmost milking cow pens. Drainage from the southernmost pens enter this drainage pathway. This drainage pathway routes water to the west side of the facility. Camera photograph #SAM 2762.

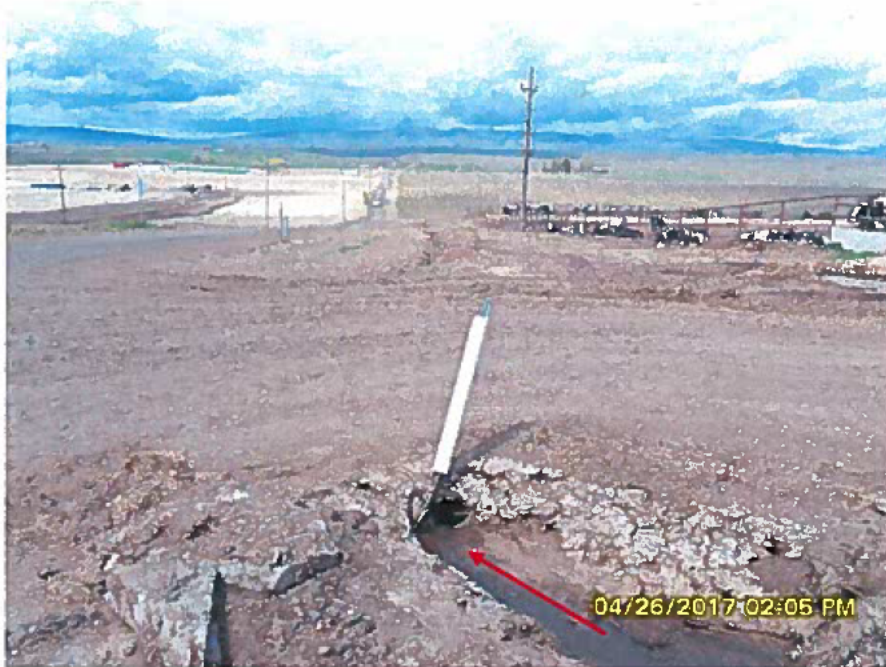
Photo #6: Northerly view showing a culvert along the west side of the confinement area that receives drainage from the pathway shown in the previous photograph. This culvert routes drainage to the north. Camera photograph #SAM 2763.

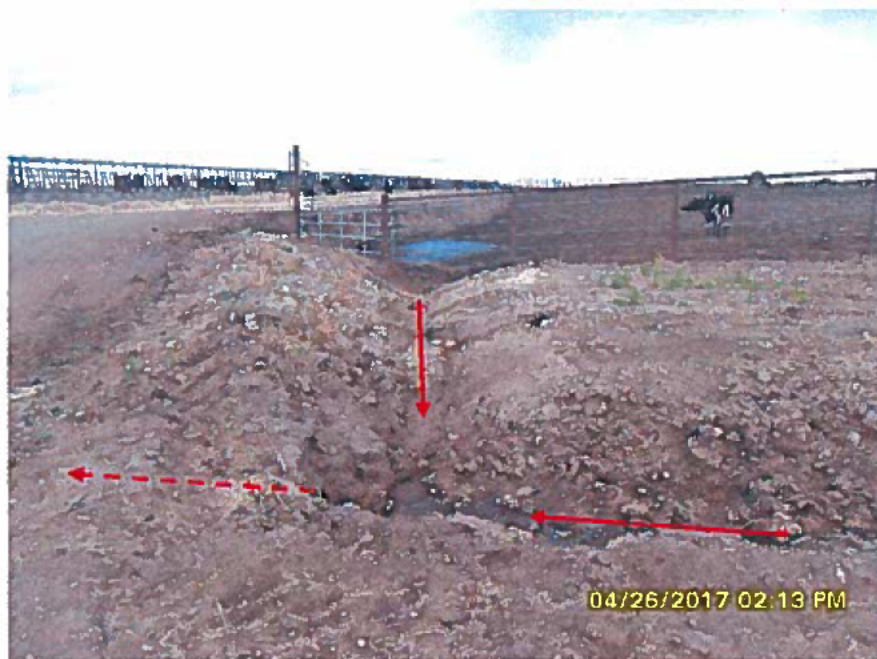
Photo #7: Easterly view showing the drainage pathway near the northwestern corner of the northernmost milking cow confinement pen. Drainage entering this pathway is routed to the retention pond located near the northwest corner of the facility. Camera photograph #SAM 2764.

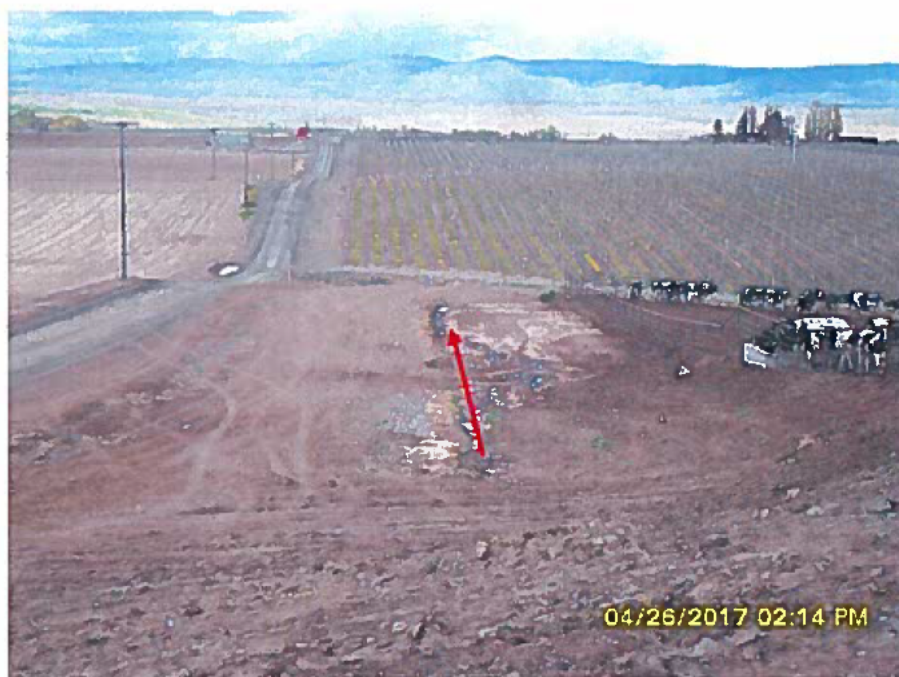
Photo #8: Northerly view along the west side of the confinement area. Note the dry cow pens on the right side of the photograph. Also note the drainage that is routed to the retention pond on the northwest corner of the property. Camera photograph #Sam 2765.

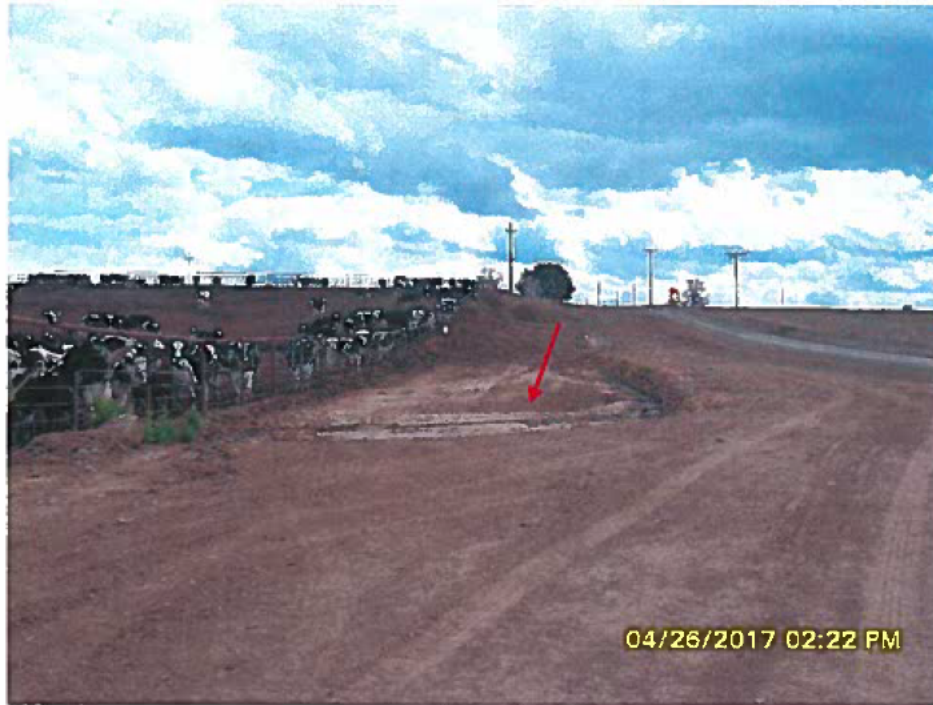
Photo #9: Southerly view showing the west side of the dry cow confinement area. Drainage in this area is routed north to the retention pond located in the northwest corner of the facility. Camera photograph #SAM 2766.

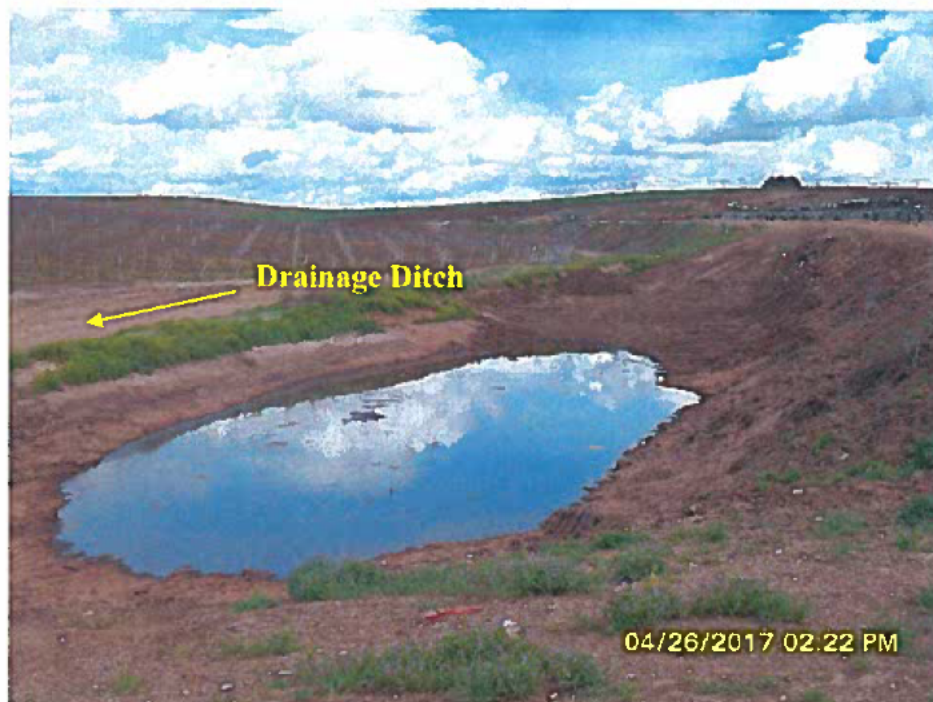
Photo #10: Easterly view showing the retention pond located near the northwest corner of the facility. Water from this pond is pumped to the lagoon as needed. Camera photograph #2767.

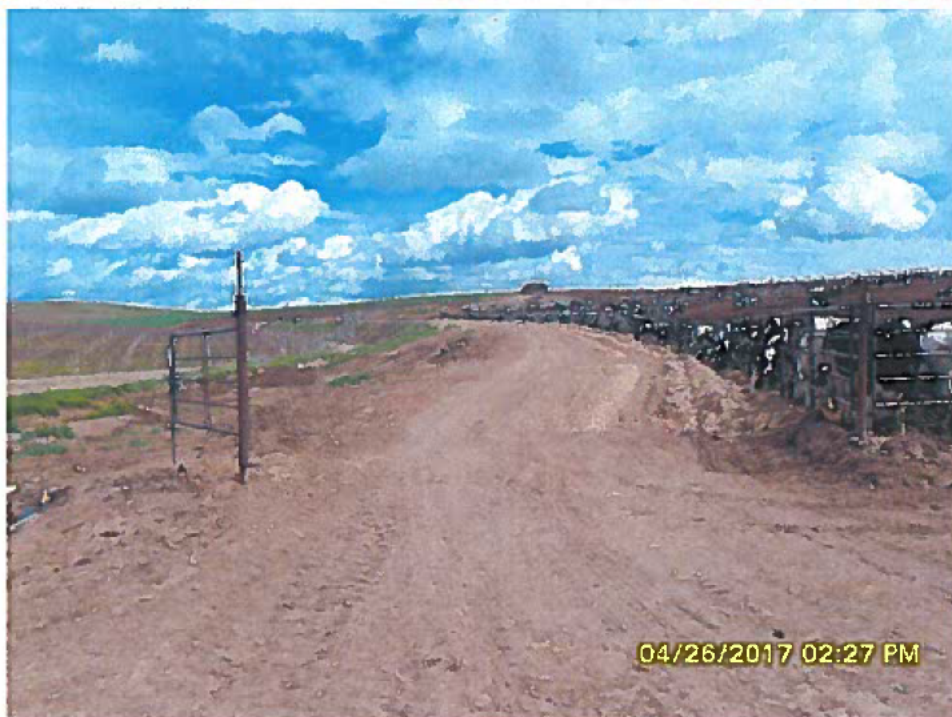
Photo #11: Easterly view showing the access road along the north side of the facility. This photograph was taken near the northwest corner of the facility. Camera photograph #SAM 2768.

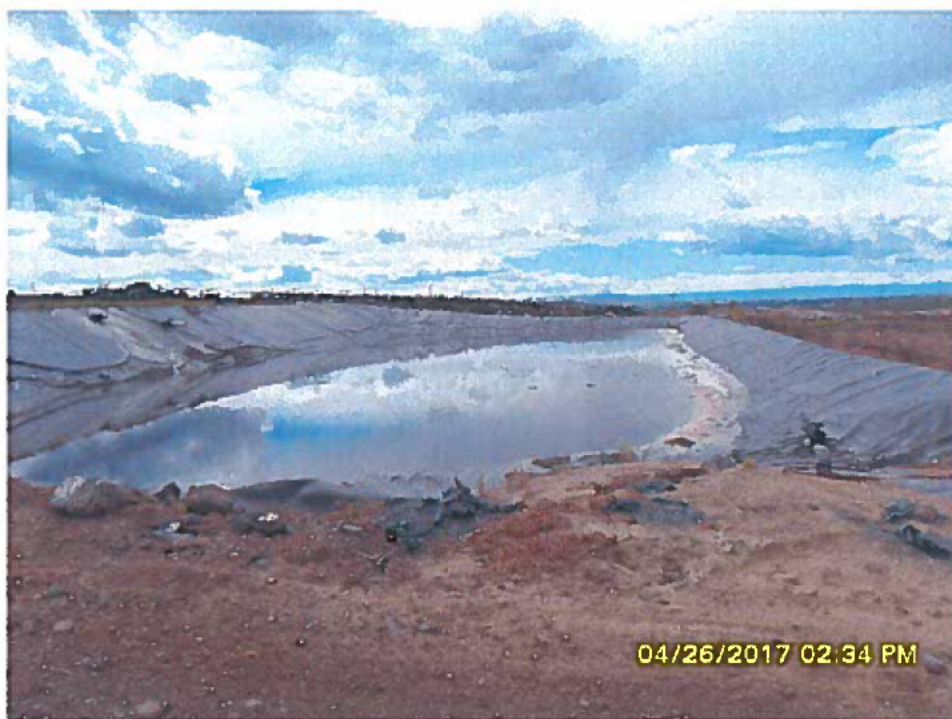
Photo #12: Westerly view showing the lagoon. This lagoon was lined with plastic approximately two years ago. Camera photograph #SAM 2769.

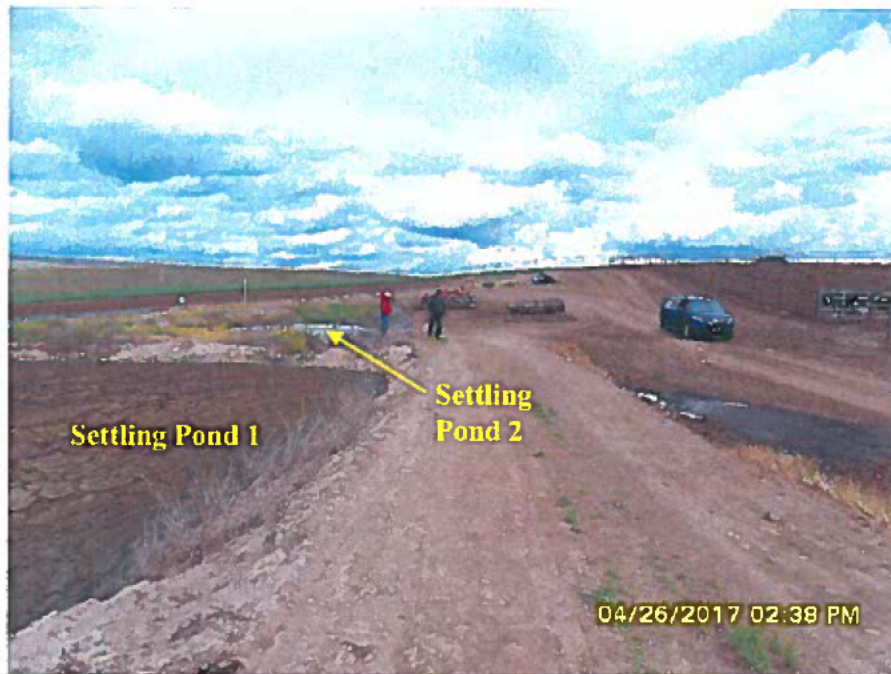
Photo #13: Easterly view showing the two settling ponds on the left. The confinement areas are located to the right of the photograph. The main lagoon is located to the left of the photograph. Camera photograph #SAM 2770.

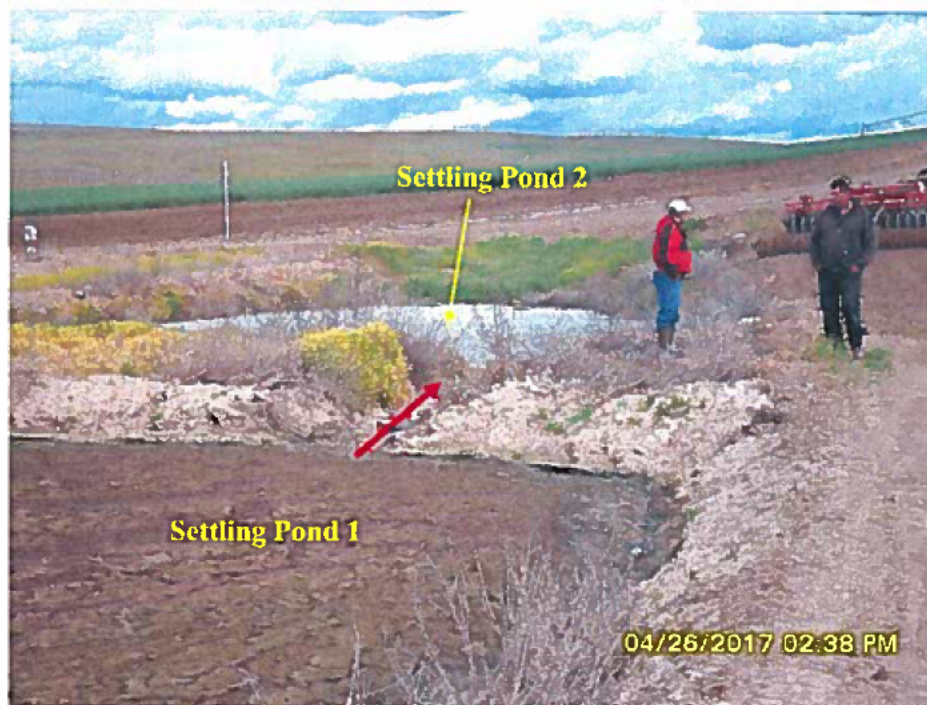
Photo #14: Easterly view showing settling pond 1 in the foreground and settling pond 2 in the background. The confinement areas are located to the right of the photograph. The main lagoon is located to the left of the photograph. Camera photograph #SAM 2771.
